**North American Society for Trenchless Technology (NASTT)
No-Dig Show 2011**

Paper C-3-03

DEALING WITH H₂S CORROSION IN THE GORDON TRUNK SEWER

¹ Environmental & Engineering Services, City of London, London, ON

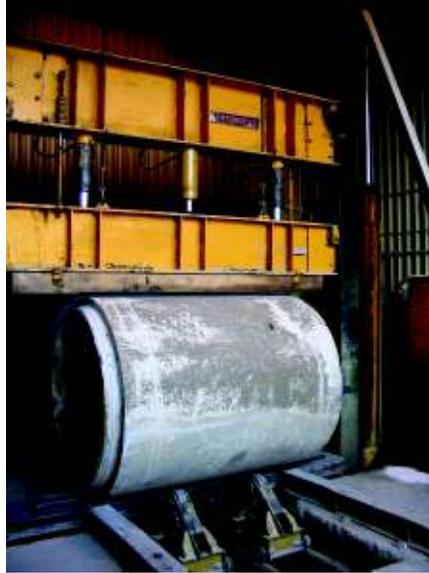
Sections of corroded pipe were taken from this project to be tested. The results were that the pipe kept strength up to 90D². These results led the City to believe that although badly corroded the pipe retained enough strength to allow several years to carry out a rehabilitation strategy.

Figure 1: Three edge bearing test on corroded 48” diameter specimen with 40 years of service.

Test results showed that the subject pipe had only lost approximately 10 percent of its load bearing capacity. This was welcome news since a number of sewer sections with WRc condition 4 (“poor”) and 5 (“bad”) ratings still remain within the system. Though catastrophic pipe collapses cannot be ignored, the test data seemed to suggest a lower probability of this occurring. However, a subsequent inspection of the system in 2009 revealed that the softened concrete continued to wash away and the rate of deterioration increased. Thus a rehabilitation plan was made a priority.
