Con^{mic}Shield[®] Additive Proves Long-Term Corrosion Protection in St. Louis Drop Shaft

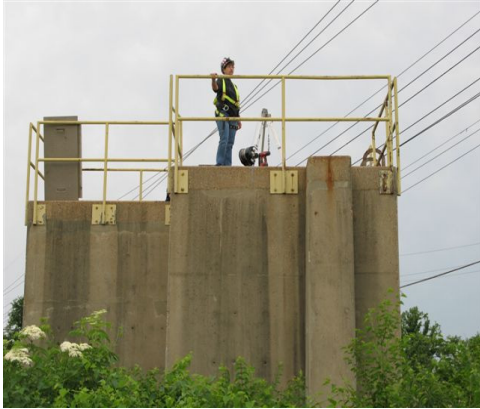
The Maline Drop Shaft located near the Chain of Rocks Bridge is just like concrete sewer structures everywhere. They corrode when hydrogen sulfide gas is present. Moderately-high temperatures, long retention times, high biological oxygen demand (BOD) levels, and turbulence contribute to elevated levels of hydrogen sulfide gas which, in turn, provide the food for acid-producing bacteria. The technical name for this process is *Microbiologically Induced Corrosion (MIC)*. This 40-year-old concrete structure was severely deteriorated from MIC. The upper portion of the walls were mushy with more than two inches of the original wall missing; in the lower half of this 50-foot-deep structure, more than five inches of the walls had corroded away.

Eight years ago, St. Louis MSD chose Specialty Sewer Company, now ADS Environmental Services, a licensed Permacast[®] applicator in the St. Louis area, to provide the quickest and most cost-effective method to restore the structural integrity of this severely-corroded structure and to prevent future corrosion. Specialty Sewer Company partnered with Spray-Com, another licensed Permacast[®] applicator with extensive experience in deep structures, for this project. A crew of five worked for 32 days and did the following to restore the structure:

- Power washed the walls back to solid material
- Stapled wire mesh to the walls for structural reinforcement of the worst areas
- Applied MS-10,000, a cementitious grout fortified with Con^{mic}Shield[®], in one inch lifts
- Troweled surface after each layer to ensure a densely-compacted, uniform finish
- Troweled smooth a final one-inch layer when the entire wall was rebuilt to the plumb line

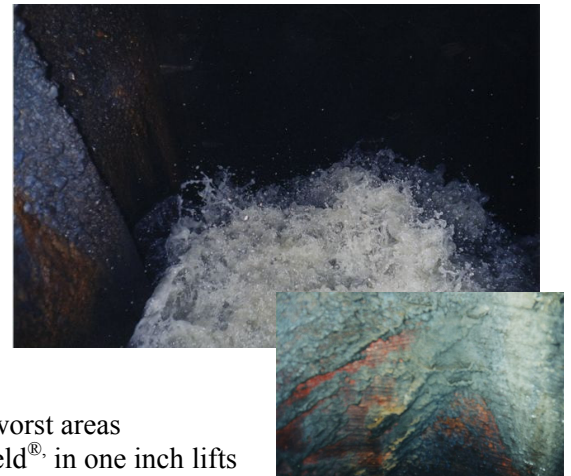
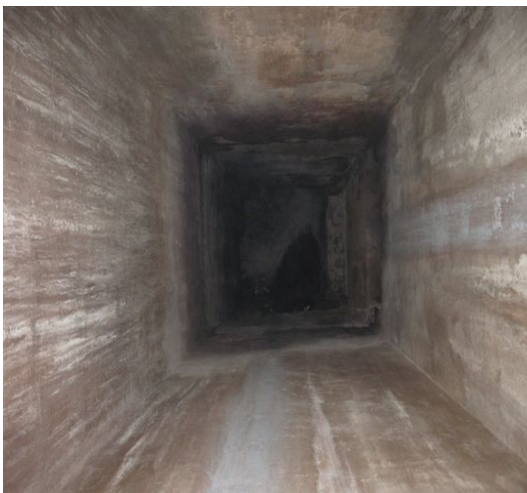
Upon completion of the job, the structural integrity of the Maline Drop Shaft was restored to a better than new condition. Thanks to the addition of Con^{mic}Shield[®] to the MS-10,000 liner grout, the drop shaft is permanently protected from future MIC damage. The Con^{mic}Shield[®] additive kills the sulfuric acid-producing bacteria; and, since it is molecularly bonded to the cementitious liner grout, it cannot wash off, chip off, delaminate, or pinhole. In the eight years since the restoration of the Maline Drop Shaft, yearly interior inspections reveal that corrosion has stopped, and only 3/32" of the wall has been lost to abrasion or erosion. This quick and cost-efficient solution to the MIC damage in the Maline Drop Shaft has greatly extended its life in spite of the continued unstoppable and highly-turbulent flows and extremely-high levels of hydrogen sulfide gas.
